CHNEP Conservation Grant FY2021 – Final Report

Project Title: *A Bird's Eye View of Caloosahatchee Conditions: A Weekly Collection of the Effects of Lake Okeechobee Regulatory Releases*

Subject: Caloosahatchee & Estuary Conditions Report

Reporting Period: September 14 – 20, 2021

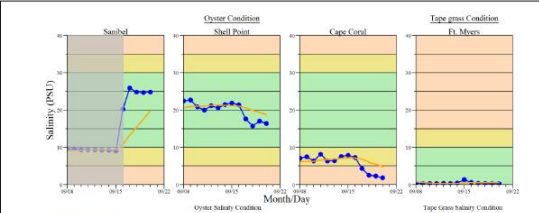
Daily average bottom salinity data for the last 14 days from sampling locations within the tidal Caloosahatchee River Estuary relative to oyster health (Sanibel, Shell Point and Cape Coral) and tape grass (*Valisneria americana*) health (Ft. Myers only) conditions.

*The salinity sensor at the Sanibel location was temporarily out of service (grey box) (since the end of August to 9/16/21).

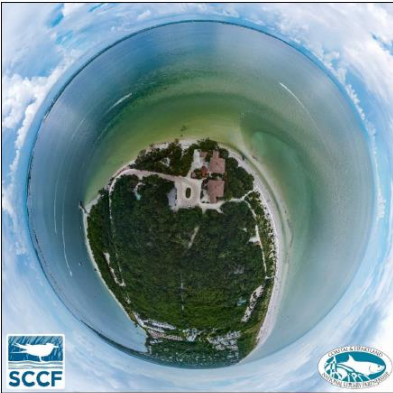
Fig 1: The “Caloosahatchee & Estuary Conditions Report” featuring a little planet view of Lighthouse Beach Park.

Water clarity at Lighthouse Beach Park on 9/17/21 at 1:55 PM on a falling tide (High tide: 3.23 ft @ 9:53 AM). [Lighthouse Beach Park virtual tour.](#)

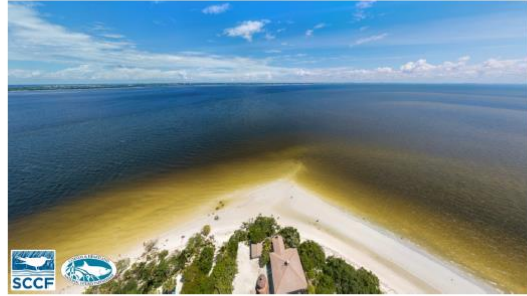
Figure 2: The “Weekly Water Conditions Update” featuring a view of Lighthouse Beach Park.

[Click here](#) or on the image above to take a virtual tour from above Lighthouse Beach Park to see how the water looked this week.

With no flows from Lake Okeechobee, water clarity and quality is only being affected by the watershed and stormwater runoff from rain. Tropical Storm Nicholas will bring rainfall to Southwest Florida this week (9/15/21 - 9/18/21) resulting in more stormwater runoff.

- Included in the new “Weekly Water Conditions Update” which is used to provide conditions to the general public, residents, visitors, and the news media. This update distills the scientific “Caloosahatchee & Estuary Conditions Reports” in a simple and easy to understand way. This report reaches an audience of over 6,600 people who are signed up for SCCF newsletters and generates approximately 1,000 views to the 360° virtual tour website per month. (Fig. 2). <http://sccf.org/water-quality/weekly-water-conditions-tracker>

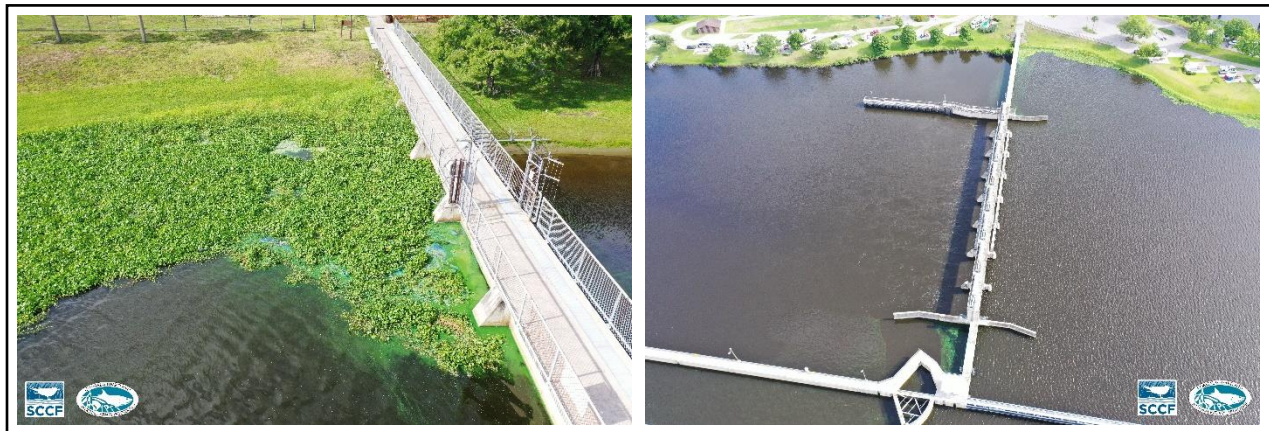
Figure 3: Cyanobacteria Blooms on the Caloosahatchee at S-79 on May 19, 2021.

- Documentation of cyanobacterial blooms at S-79 on the Caloosahatchee in May 2021 after high volume release from Lake Okeechobee that resulted in stressful 14-day average flows (2100-2600 cfs) for 5 days from May 10 – 14, 2021. (Fig. 3).

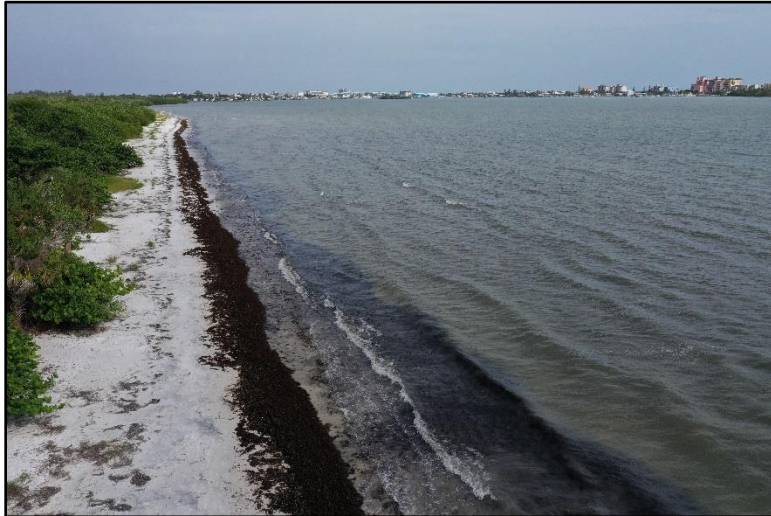
Figure 5: Macroalgae bloom at Bunche Beach on June 15, 2021

- Documentation of drift algae accumulation at Blind Pass in May 2021. (Fig 4).
- Documentation of macroalgal blooms on Bunche Beach in Fort Myers in June 2021. (Fig. 5).

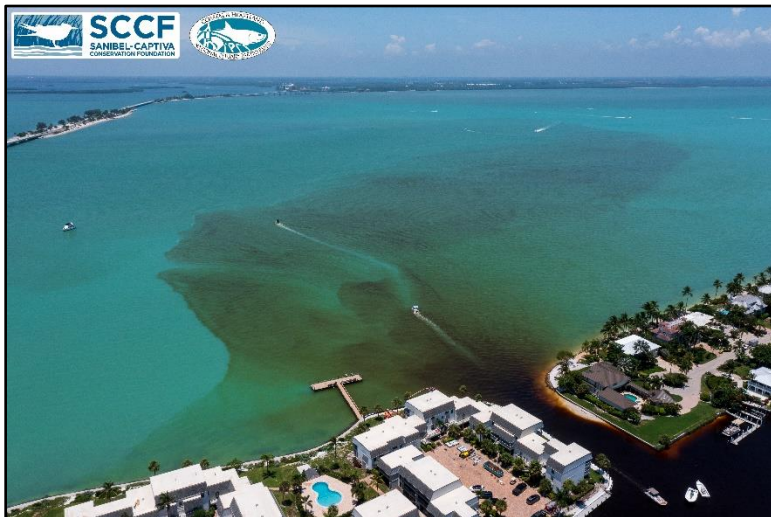
Figure 6: Brown water plume from the Sanibel River after the Beach Road weir was opened after Tropical Storm Elsa on July 8, 2021

- Documentation of the Sanibel River Plume after Tropical Storm Elsa in July 2021 (Fig. 6).
- Collaboration with the City of Sanibel to monitor progress on the Jordan Marsh plant removal. Jordan Marsh is a filter marsh used to remove nutrients from the Sanibel River. The mature plants are less effective at filtering nutrients and need to be removed periodically to restore the benefits of the marsh to the Sanibel River. (Fig. 7).

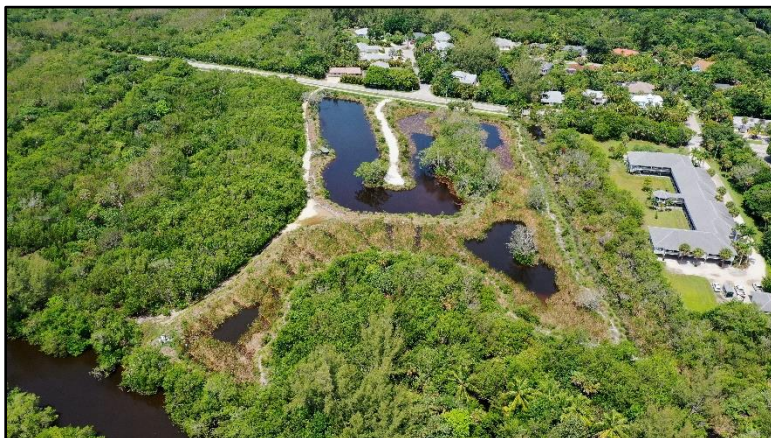
Figure 7: Monitoring of the plant removal project at Jordan Marsh for the City of Sanibel.
