Lemon Bay Basin Water Quality Status Report

WATER QUALITY IMPROVEMENT

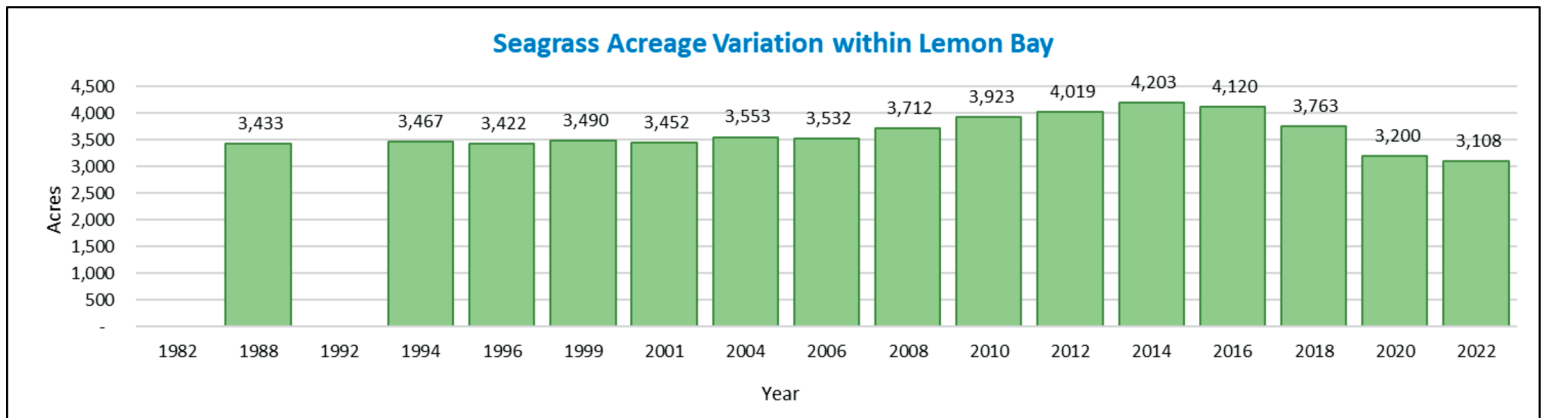
Seagrass Acreage

The table below shows results from seagrass mapping, done once every two years, in Lemon Bay from 1988-2022. Seagrass in this area has increased since the 1990's and since then remained relatively stable over time. However, acreages began to decline in between 2016 and 2018 and demonstrated more loss between 2018 and 2022. Between 2018 and 2022, Lemon Bay lost 655 acres of seagrass, representing a 17% loss overall. This is the third straight loss since 2016 with seagrass in Lemon Bay reaching an all-time historic low. The reason for this decline is complex and likely involves several factors. This includes impacts from recent storm events such as Hurricane Irma, increased temperatures and rainfall, additional nutrient runoff from land, as well as prolonged red tide and algae blooms in the region. The CHNEP continues to work with our partners to better understand causes and investigate solutions.

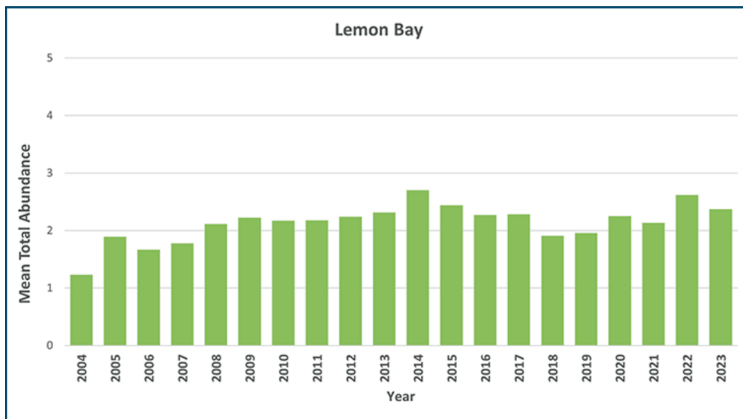
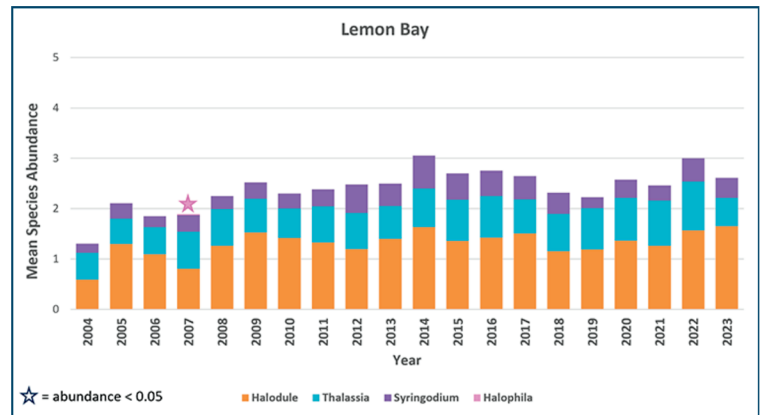
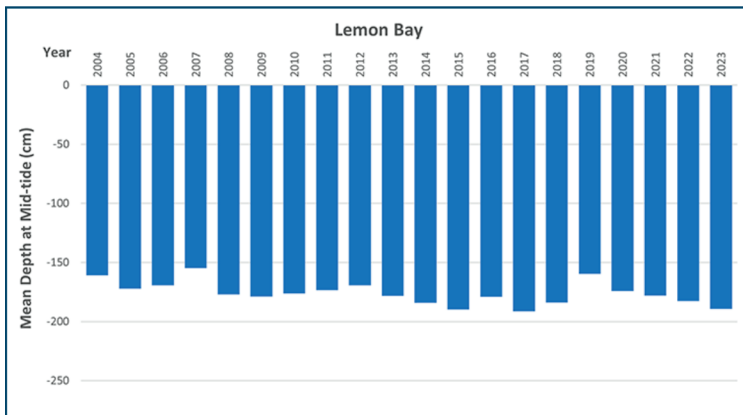
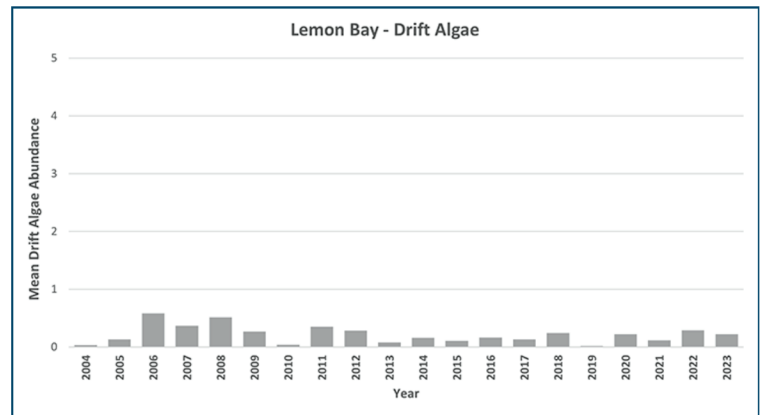
Seagrass Diversity and Health

The bar graphs here depict the changes in presence of different species of seagrass found at monitored locations in the region. In Lemon Bay this includes Shoal grass (*Halodule wrightii*), Turtle grass (*Thalassia testudinum*), and Manatee grass (*Syringodium filiforme*) for the years 2004–2023.

They demonstrate that all three types of seagrass experienced declines at multiple monitoring locations starting around 2018, preceding the decline in overall acreage observed between 2018 and 2020. Data collected in 2022 showed modest gains throughout the area, however, data collected in 2023 demonstrate losses for *Thalassia* and *Syringodium*. This loss has been coupled with increased documentation of macroalgae and cyanobacteria blooms that agencies are working to catalogue through their existing monitoring programs.
